Installation Case Study Mount Rushmore Rock Block Monitoring System (RBMS)

Keystone, South Dakota, USA

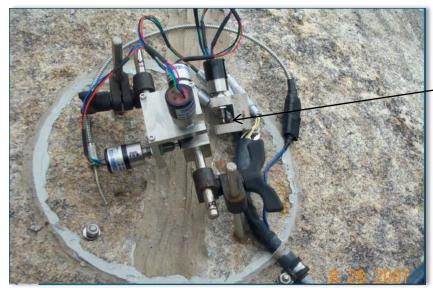
New monitoring system using os3110 fiber optic strain gages mounted on either side of the small cantilever beam. Temperature compensation is realized thru an active dummy gage configuration.

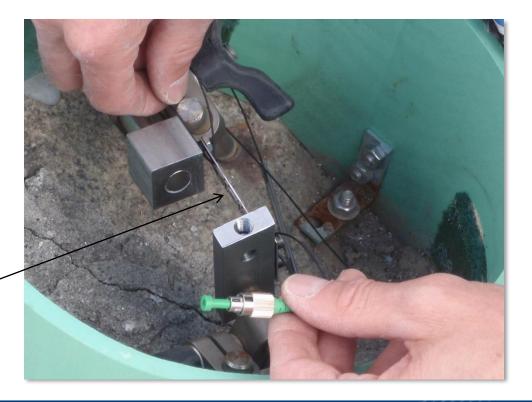
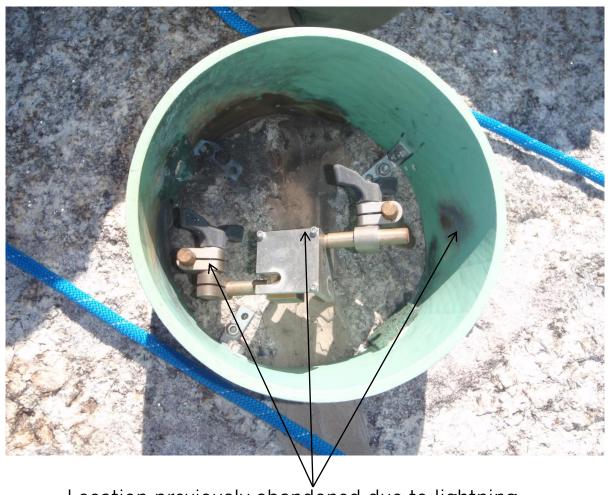
Location previously abandoned due to lightning strikes. Notice areas of charring or discoloration.

- A previously monitored station, abandoned due to lightning, has been reactivated with the fiber optic sensing system. Hundreds of pounds of copper cable was replaced with five pounds of rugged fiber optic cables. This eliminated the need for cumbersome and unattractive cable harnesses that previously were in the public view of the monument.
