Installation Case Study Roadway Monitoring

New South Wales, Australia

Road Pavement Monitoring

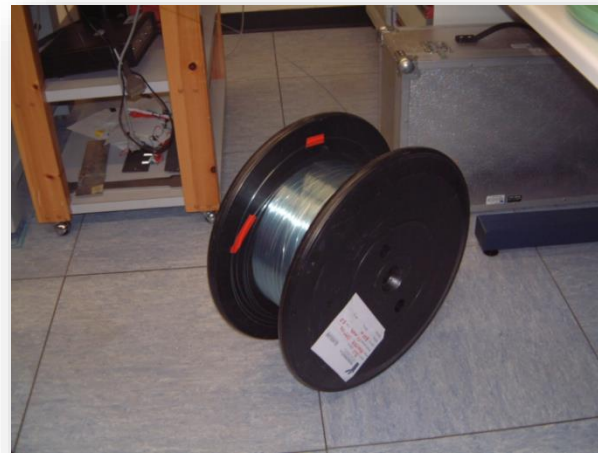
- Road pavements have suffered impacts in the form of structural distress resulting from mine subsidence movements and mining-induced ground strains. Much of the ground strain is transferred to the pavement through the ground movement and interface friction between structural layers.
- Monitor Optics Systems has developed a method of embedding one or more optical fibers into a Glass Fiber Reinforced Composite (GFRC) cable.
- These cables can be up to kilometers in length, are readily deployed in the field and provide a very high level of protection to the optical fiber while maintaining its sensitivity to changes in temperature and strain.

1 km long, 1 mm diameter cable

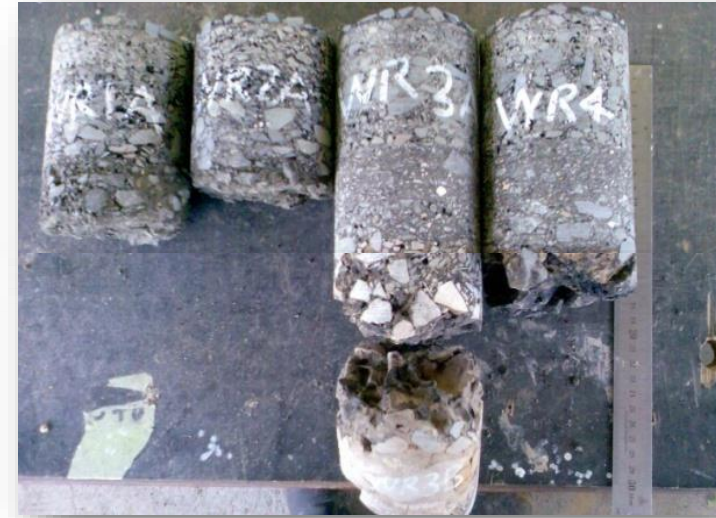
- The monitored road was subjected to mine subsidence movements during the mining of Longwall 302 at Appin Colliery, which is located in the Southern Coalfield of New South Wales. The site is approximately 90 kilometers southwest of Sydney.
- Wilton Road is a two-lane road with an asphaltic concrete (AC) pavement at this location. Four core samples were taken and these indicated a 14 mm chip seal above multiple layers of AC10 and AC14 of depths between 90 and 180 mm, with 100 mm thick sub-base of unbound or bitumen stabilized crushed rock, and a select sub-grade layer of crushed sandstone.
- Optical fiber sensors were placed in the asphalt layer approximately 5 cm below the surface along a 90 meter long section of pavement on this road.

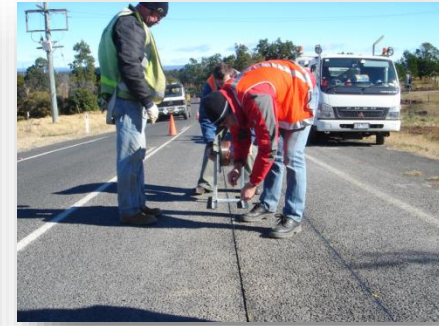
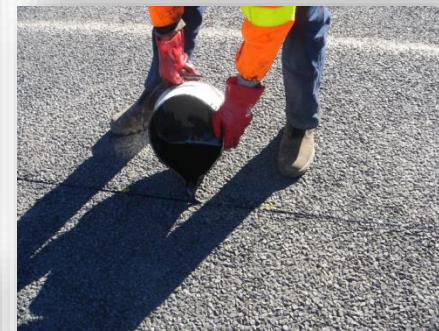
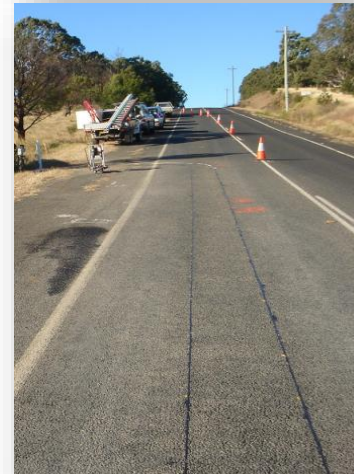
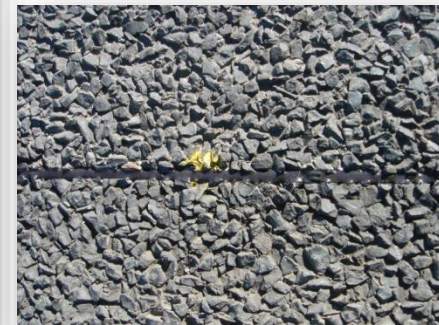
- The sensors were embedded into the pavement.
 - A groove of approximately 8 mm wide and 20 mm deep was saw cut into the pavement along the center line of the eastbound lane.
- The following cables were manually placed into the groove via spool reels:
 - One Distributed Strain Sensor Cable of 1mm diameter containing 10 FBGs at 10 m spacing.
 - One Distributed Temperature Sensor Cable of 5mm diameter containing 5 FBG temperature sensors at 20 m spacing.
- The epoxy resin was poured around the two 1 mm diameter cables in one application.

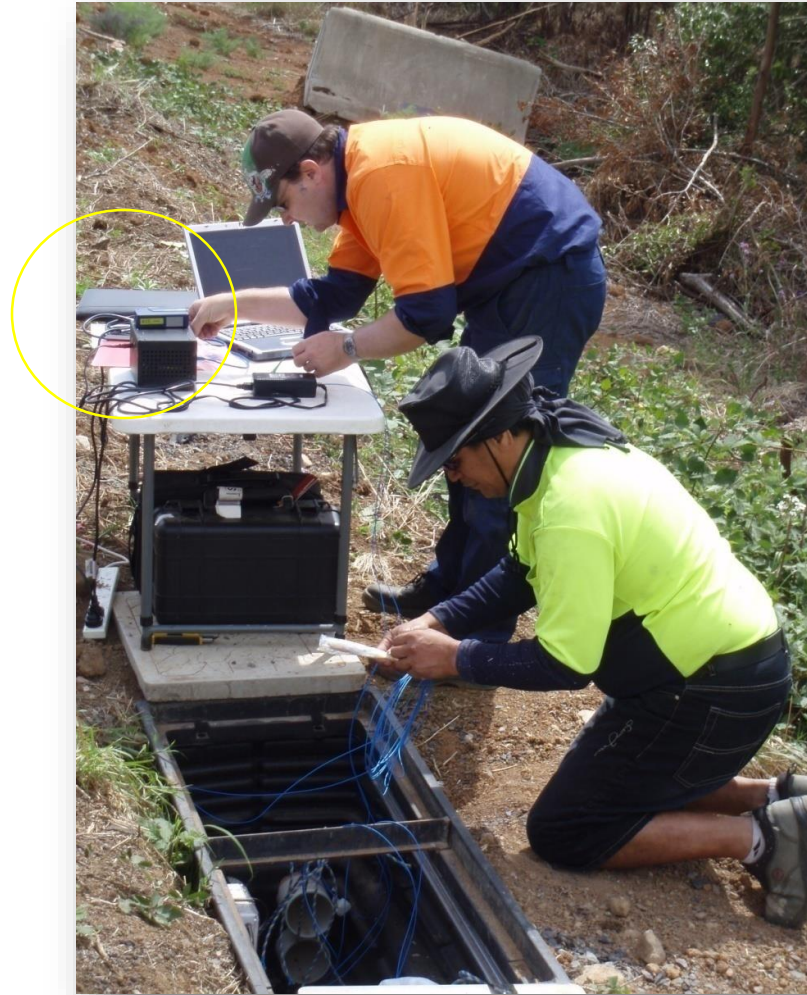
- Temperatures are accurately measured at strain sensing locations for determining thermally induced strains.
 - The temperature sensors were placed within 300 mm of the strain sensors.
- The sensor cables were terminated in a buried pit at each end, located just beyond the pavement shoulder.
 - The cables at one pit were connected to signal carrying cables that were connected to an interrogator housed in a secure container.
 - The cables at the second pit were coiled up and prepared for future connection should some or all of the cables experience a break during mining.
- The installation of the optical fiber cables was very successful and all FBG sensors were operational.
- A Luna sm125 (see photo) instrument was used in the field for its proven reliability and accuracy.

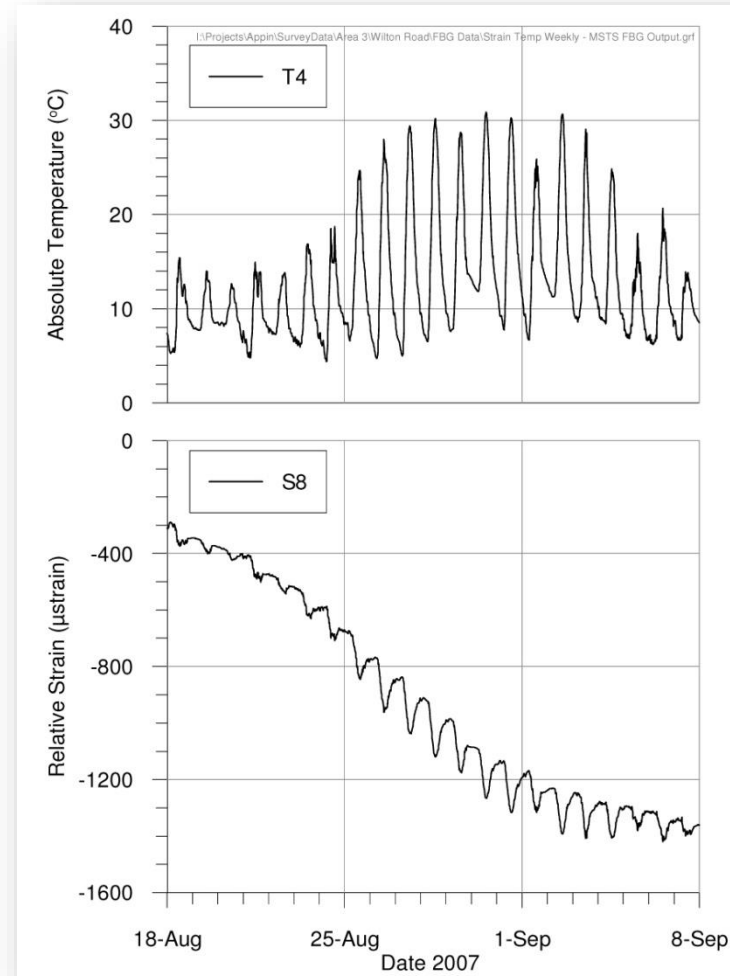
- Monitor Optics Systems (MOS) recorded readings taken at 15 minute intervals. Ground surveys were conducted at weekly intervals.
- MOS converted the raw FBG output into temperature and strain.
- The output shows the results from one strain sensor (S8) and the temperature sensor (T4) at a time in which subsidence was most active during the project.
- It can be seen from the results that both temperature and strain follow a diurnal pattern and that a compressive strain is building up due to subsidence from mining.

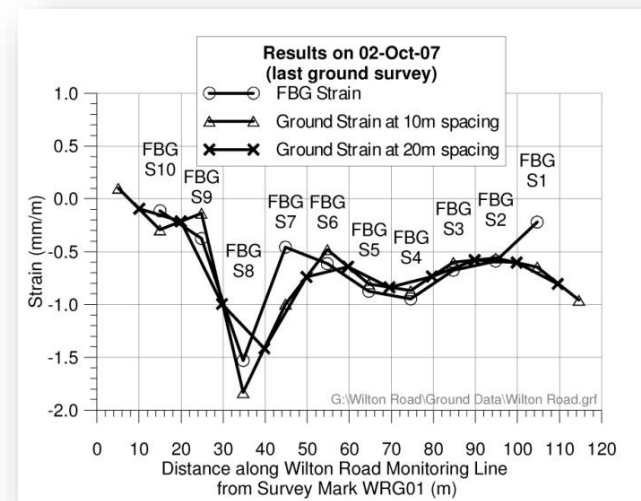
- Computer programs were used to automate the data collection and analysis during the mining period.
- Mining-induced strains were calculated every 15 minutes and the results are shown in the graph.
- Calculations were made over 20 meter bay lengths and correlation between ground strain and FBG strain is good for either bay length.
- The good correlation indicates that full transfer of ground to pavement strain occurs with little or no redistribution of strain along the pavement.

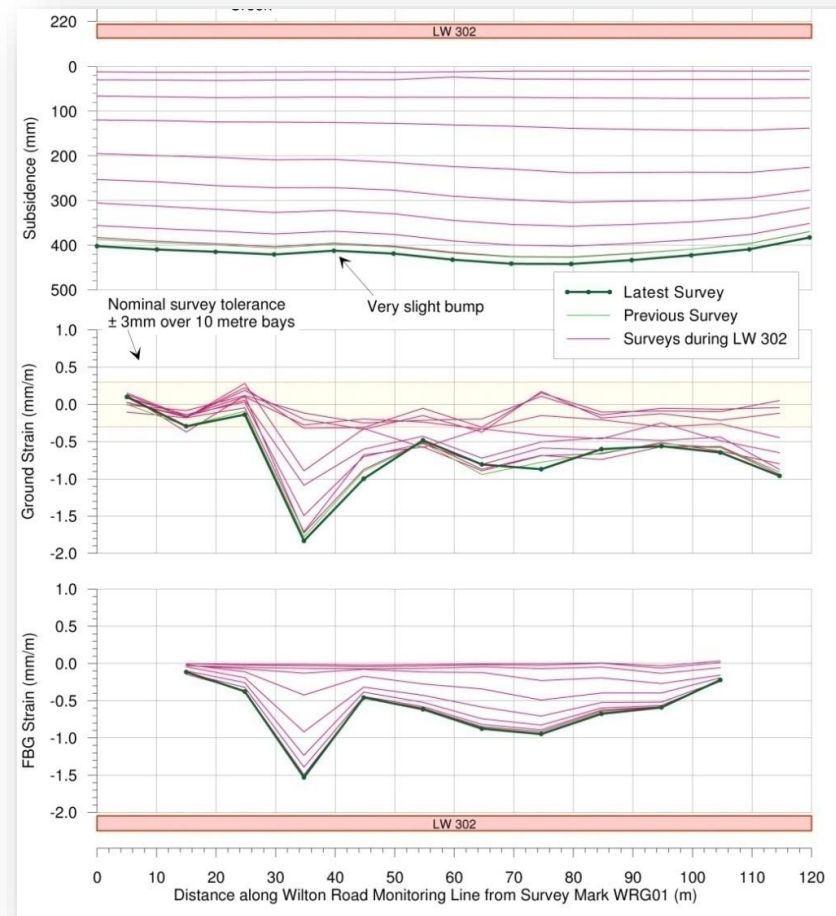
- A comparison between subsidence, ground strain and calculated mining strains from the FBG results (FBG strain) along Wilton Road.

- The results indicated a very good correlation between ground and pavement strain at all times.
- Comprehensive pavement risk management requires that the FBG-based monitoring is conducted in conjunction with other monitoring such as ground survey and visual monitoring.
