Installation Case Study Mount Rushmore Rock Block Monitoring System (RBMS)

Keystone, South Dakota, USA

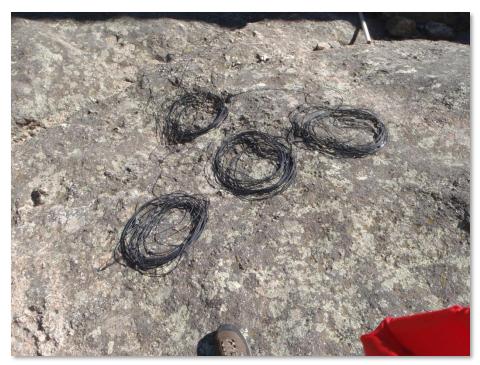
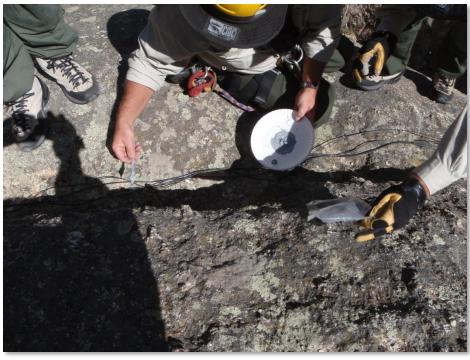
Installation of cables to each of the four monitoring locations.

Securing the tie down clips to the rock with epoxy for securing the cables.

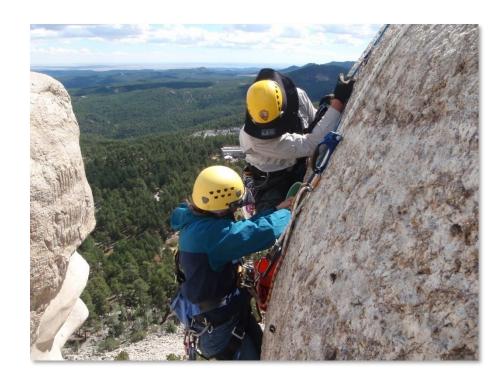
Location previously abandoned due to lightning strikes. Notice areas of charring or discoloration.

- A previously monitored station, abandoned due to lightning, has been reactivated with the fiber optic sensing system. Hundreds of pounds of copper cable was replaced with five pounds of rugged fiber optic cables. This eliminated the need for cumbersome and unattractive cable harnesses that previously were in the public view of the monument.
